Debris/Ice/TPS Assessment And Photographic Analysis For Shuttle Mission STS-38

February 1991

DEBRIS/ICE/TPS ASSESSMENT
AND
PHOTOGRAPHIC ANALYSIS
OF
SHUTTLE MISSION STS-38

November 15, 1990

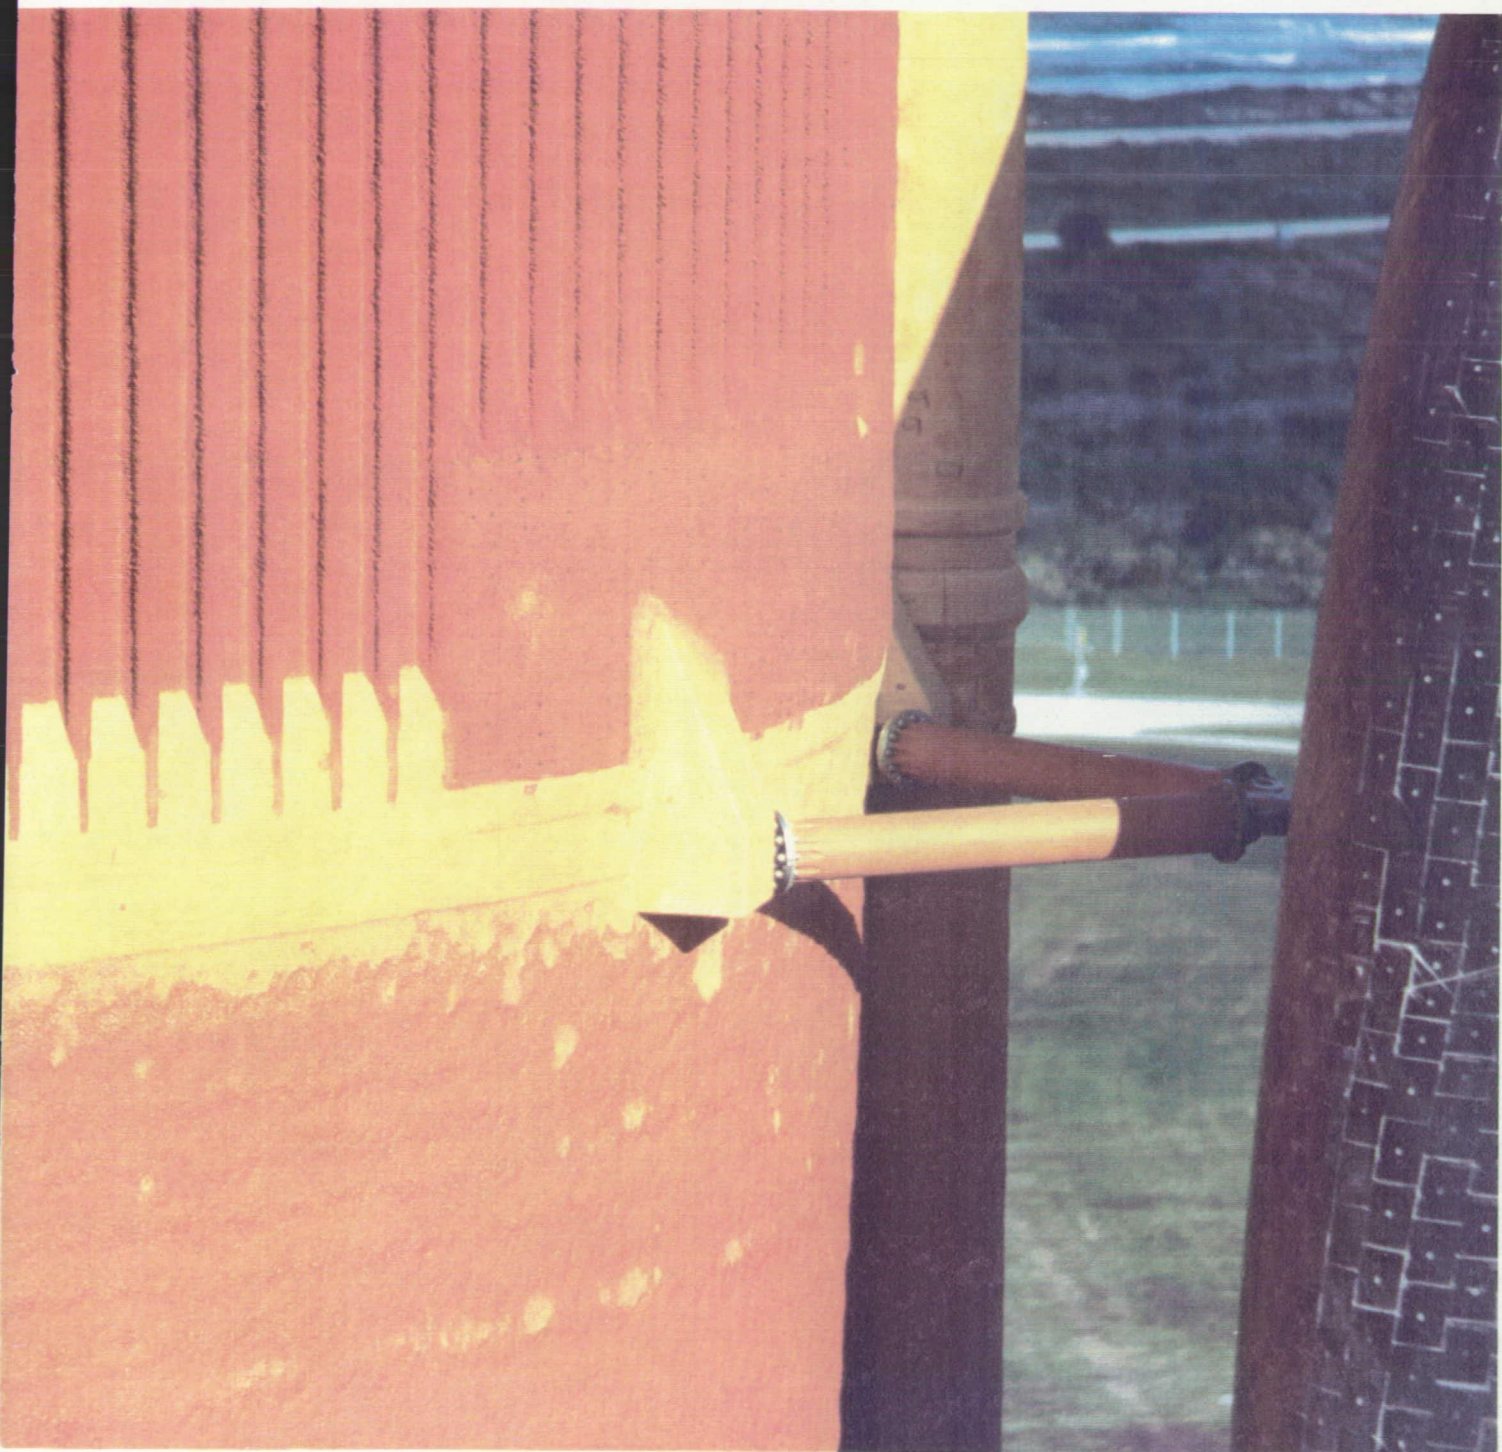
Pre-launch configuration of ET intertank/upper LH2 tank TPS.
Note pattern of vent holes drilled in TPS to vent possible
substrate voids and preclude divots during ascent.

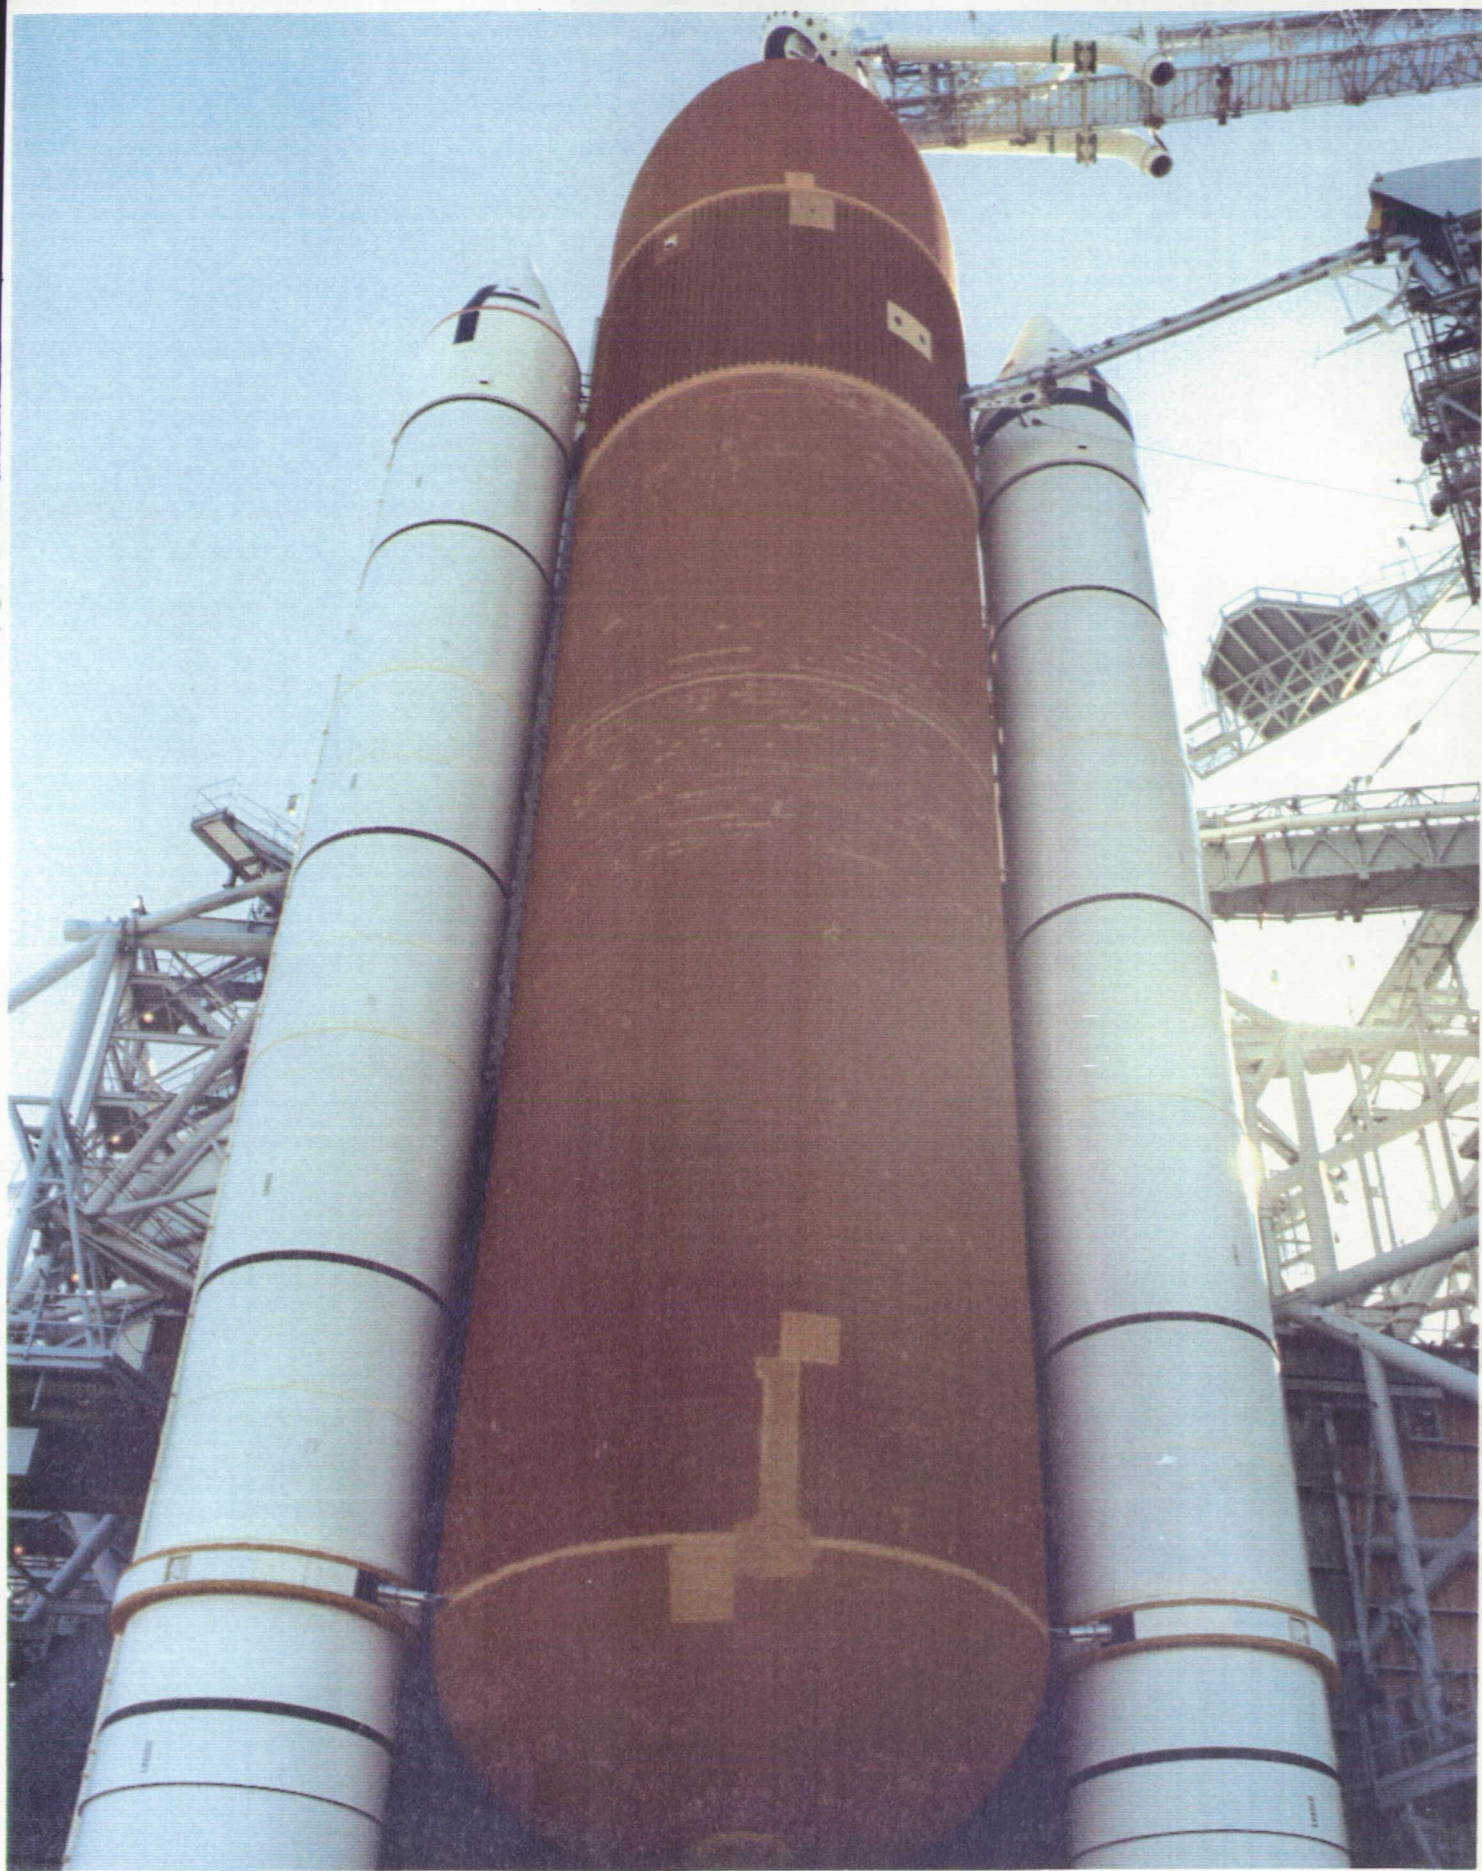
Overall view of ET-40 (LWT 33) and SRB BIO39 -Z side

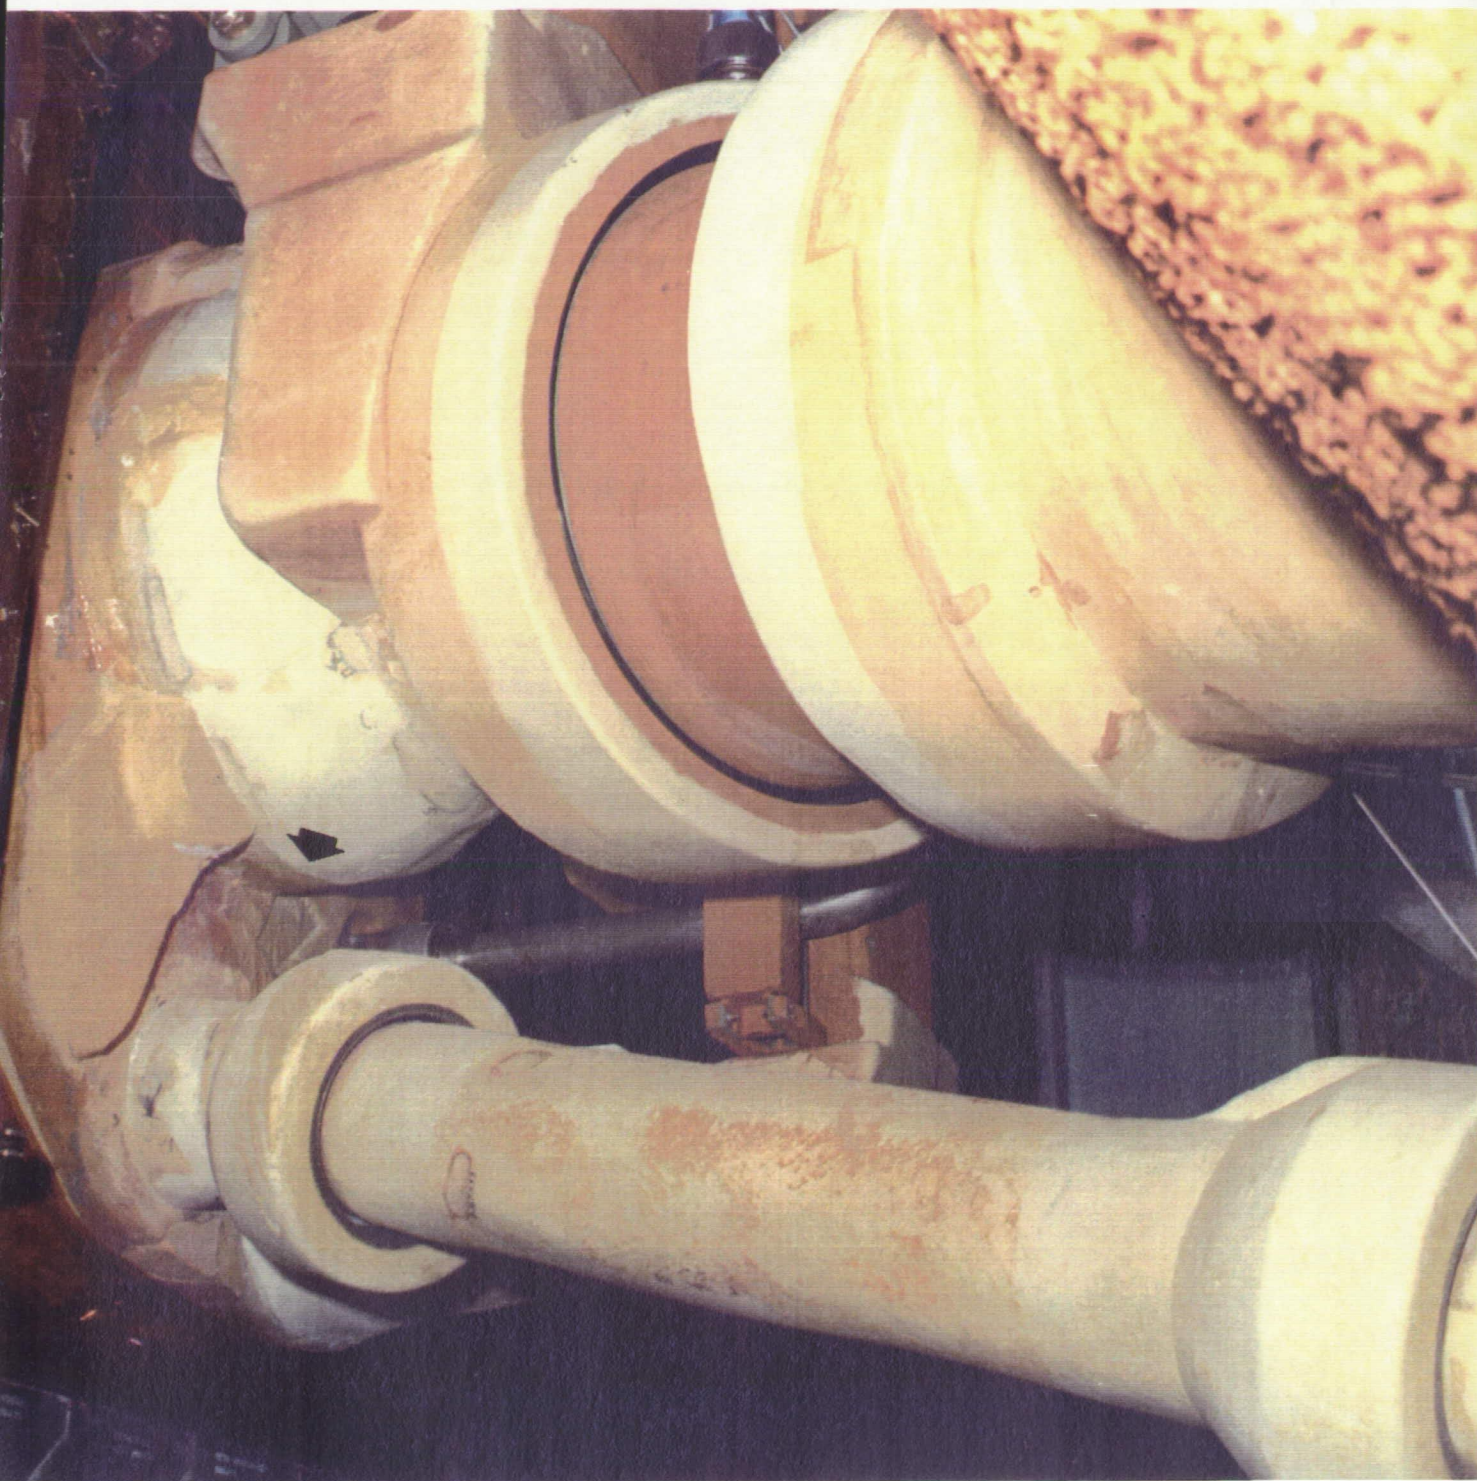
ET/ORB LH2 umbilical prior to loading of cryogenic propellants. Note configuration of 17-inch flapper valve tool access port foam plug closeout.

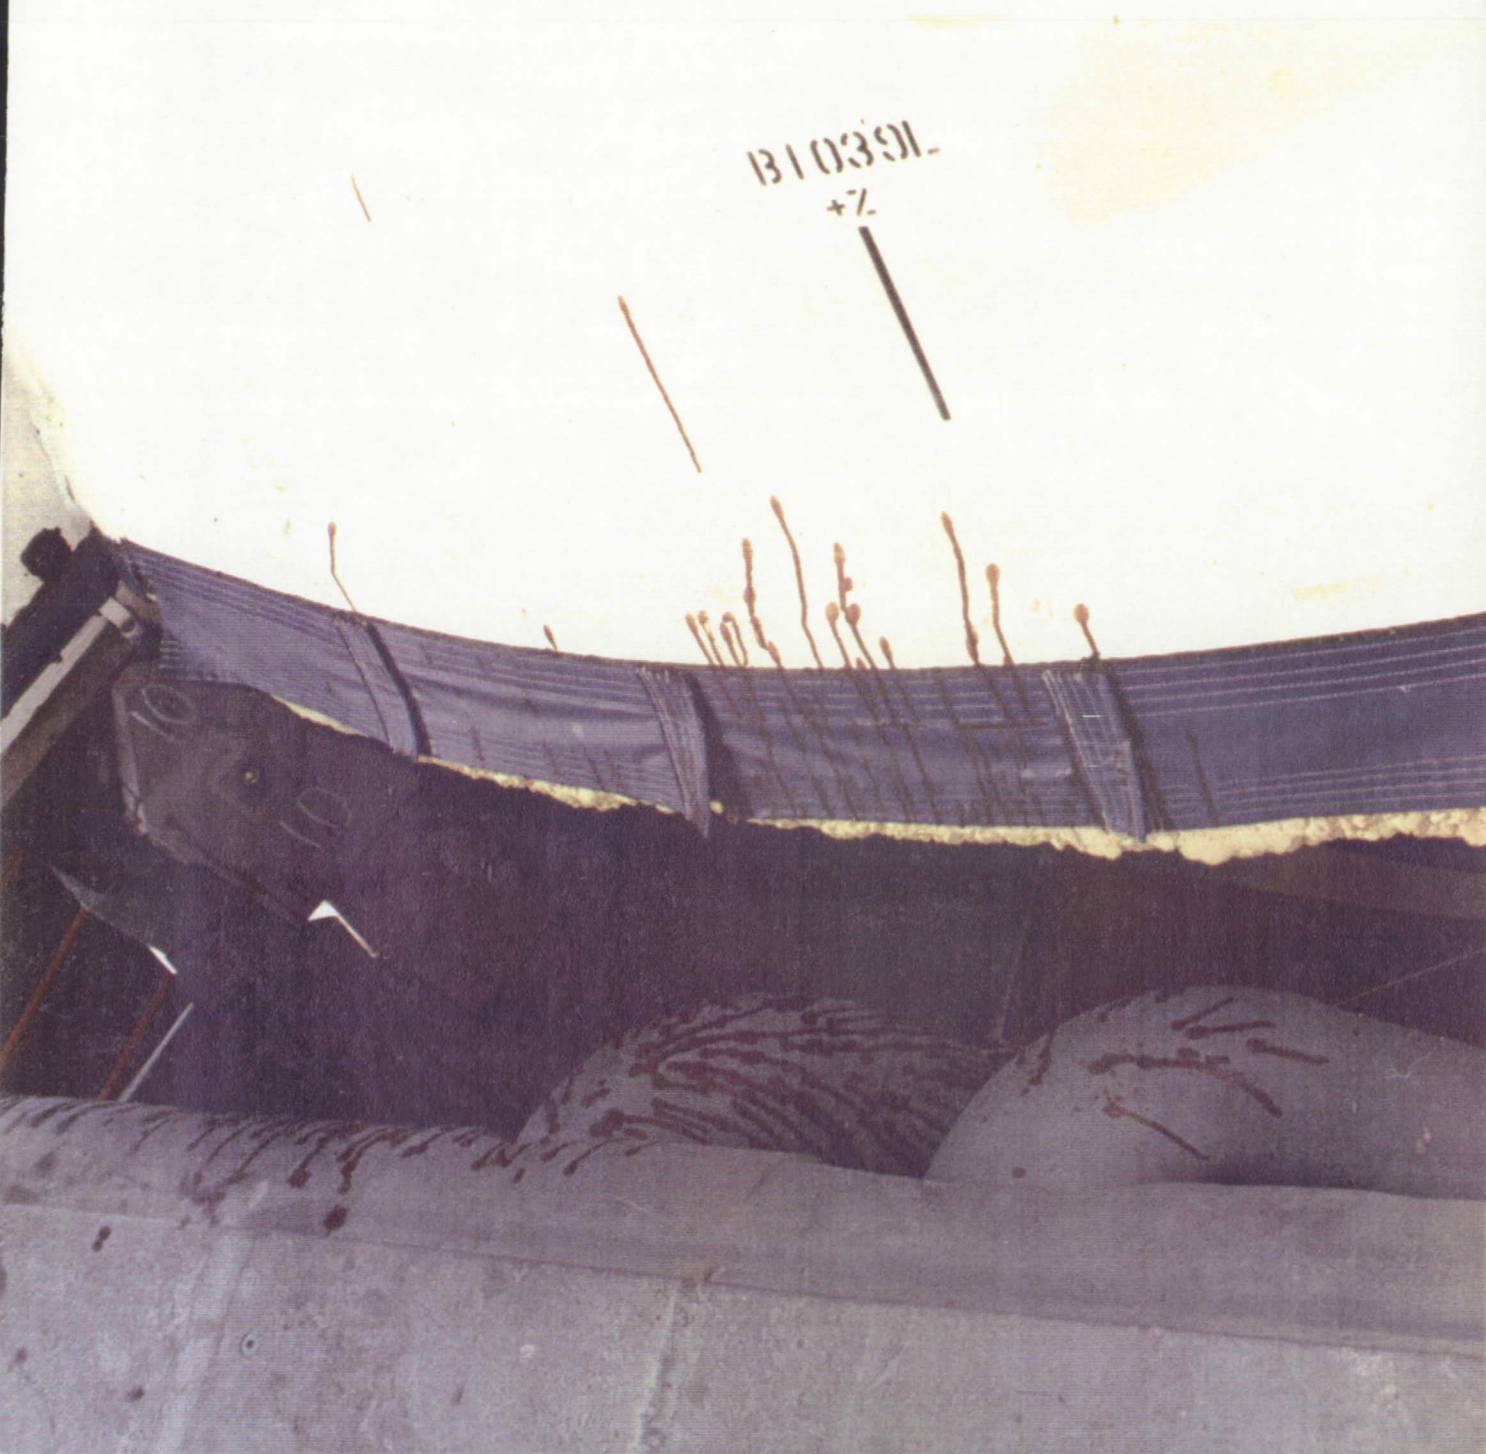
Reddish-brown liquid had dripped onto LH SRB aft skirt from
the IEA area during pad closeout operations

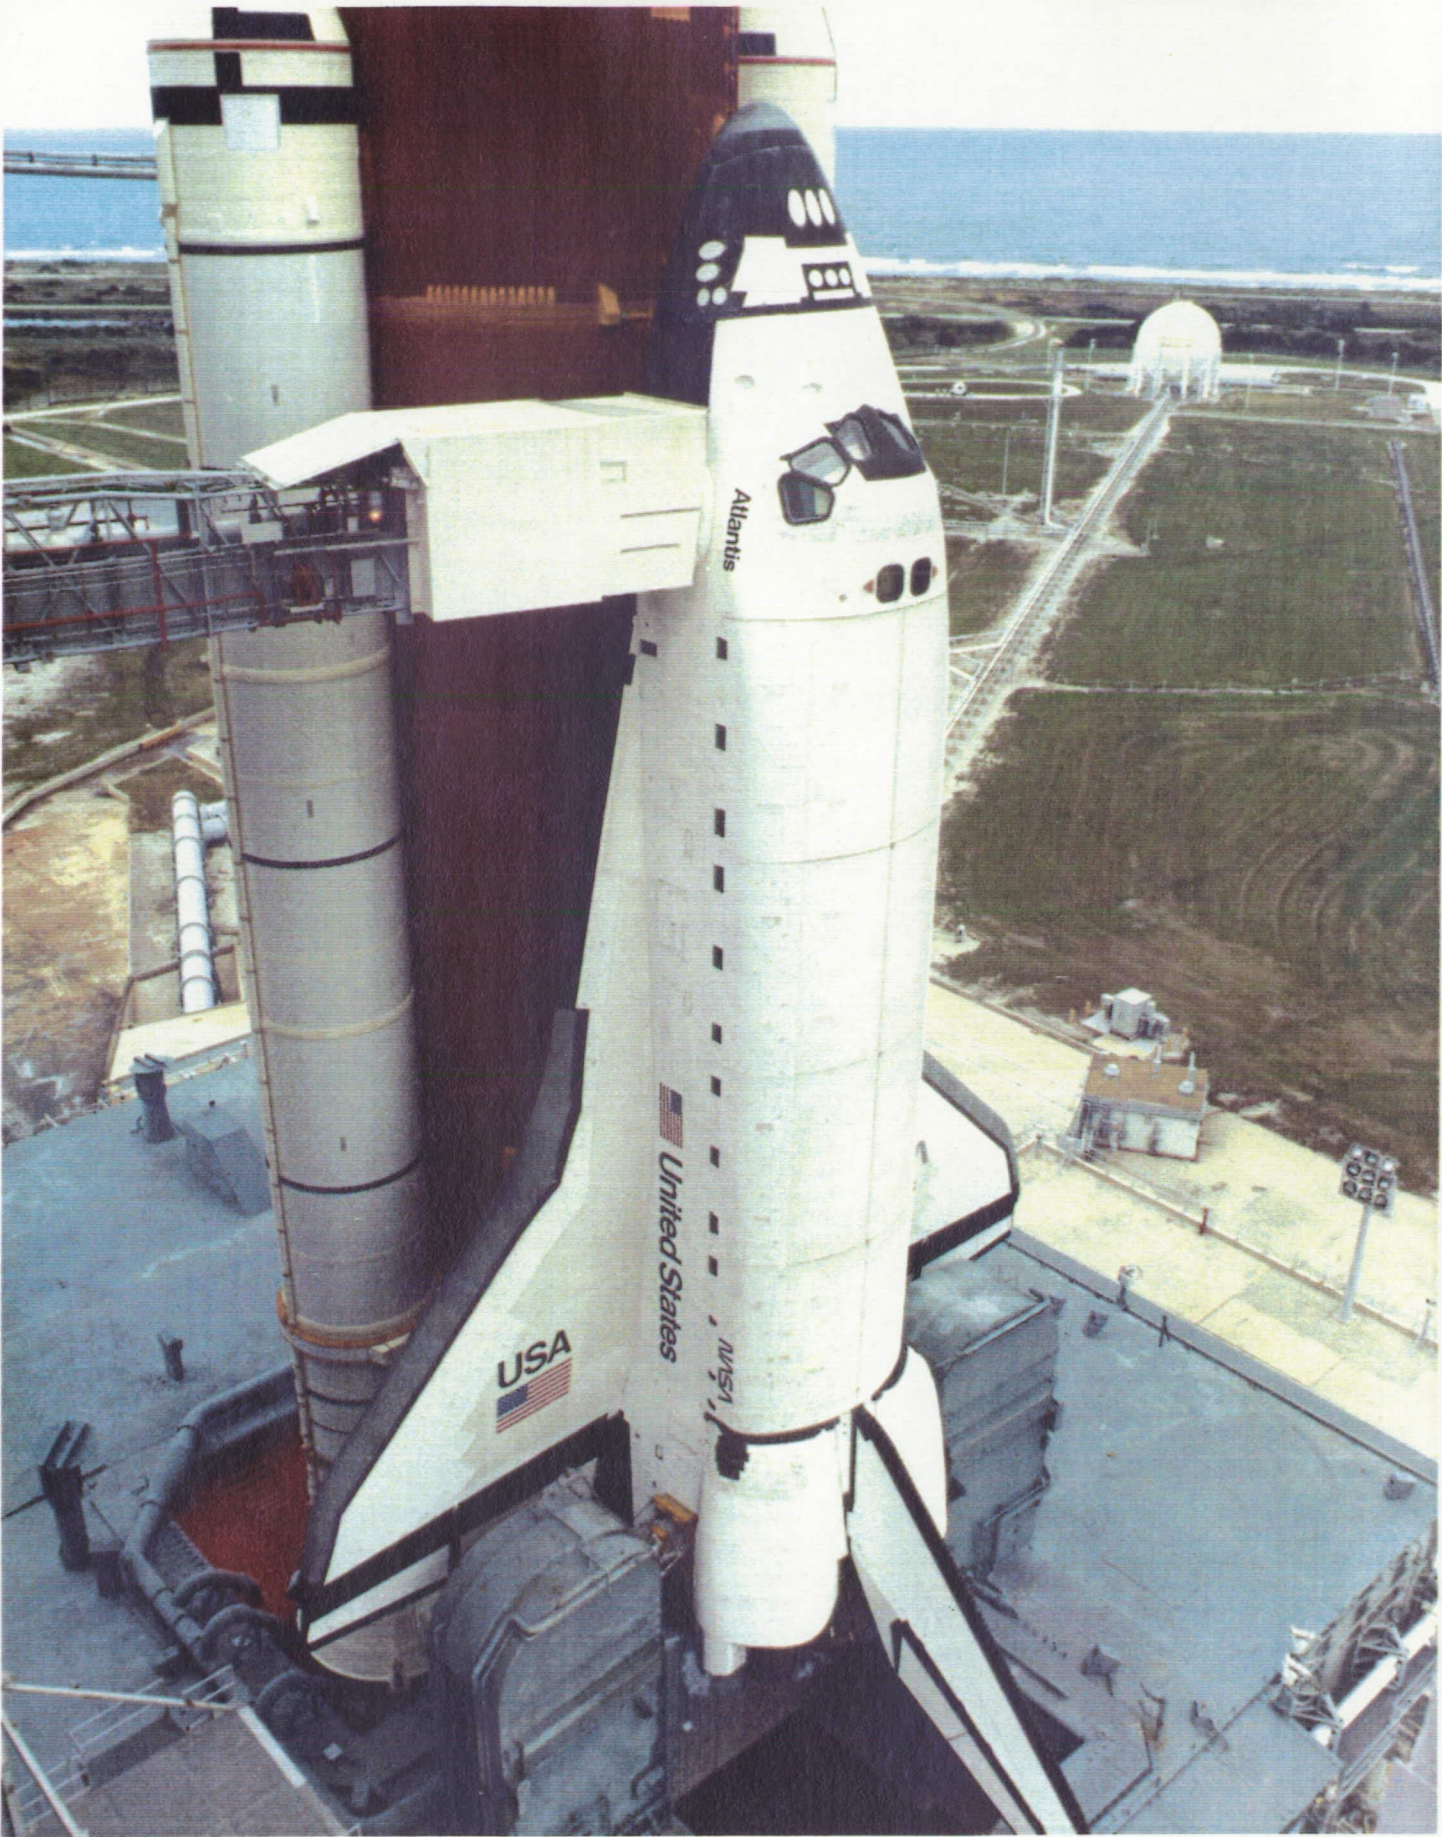
Overall view of OV-104 and +Z side of ET-40 and SRB BI039

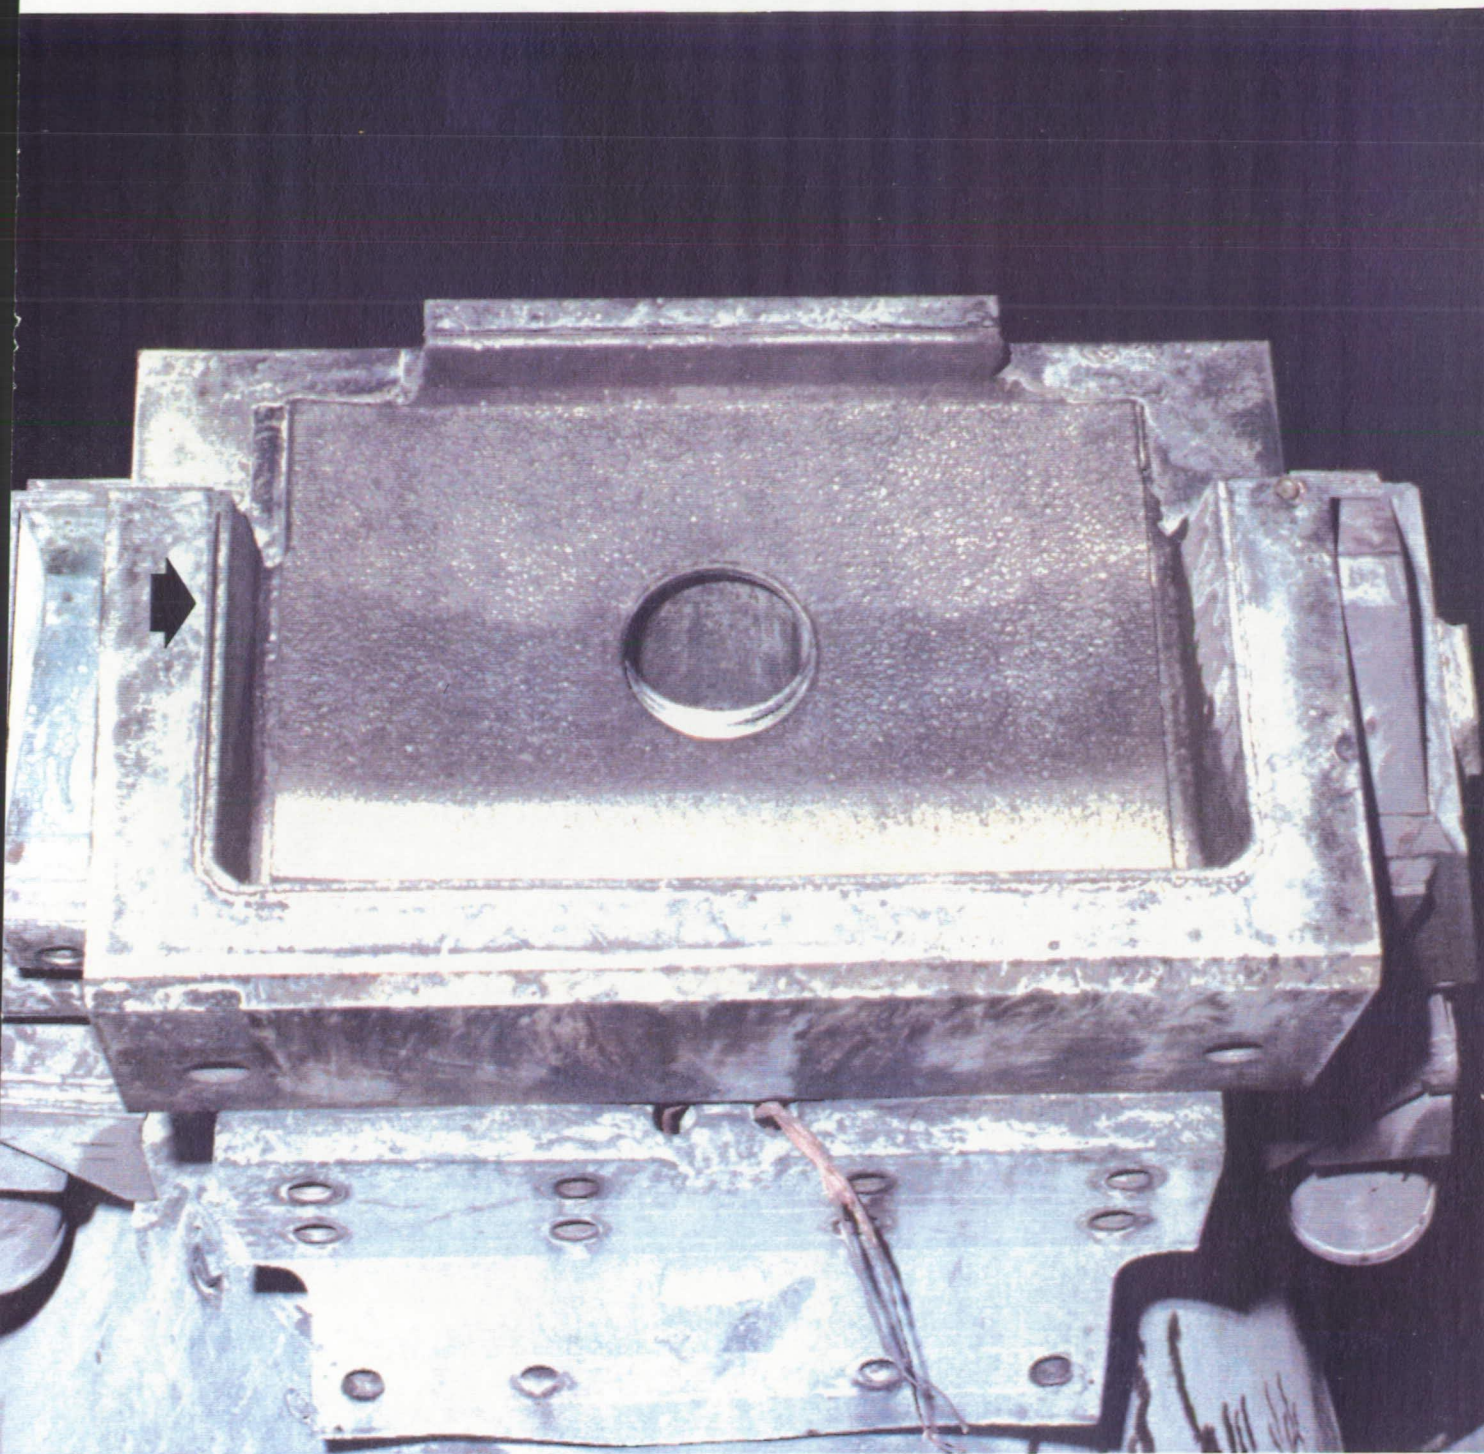
Holddown post shoe sidewall shim material was debonded

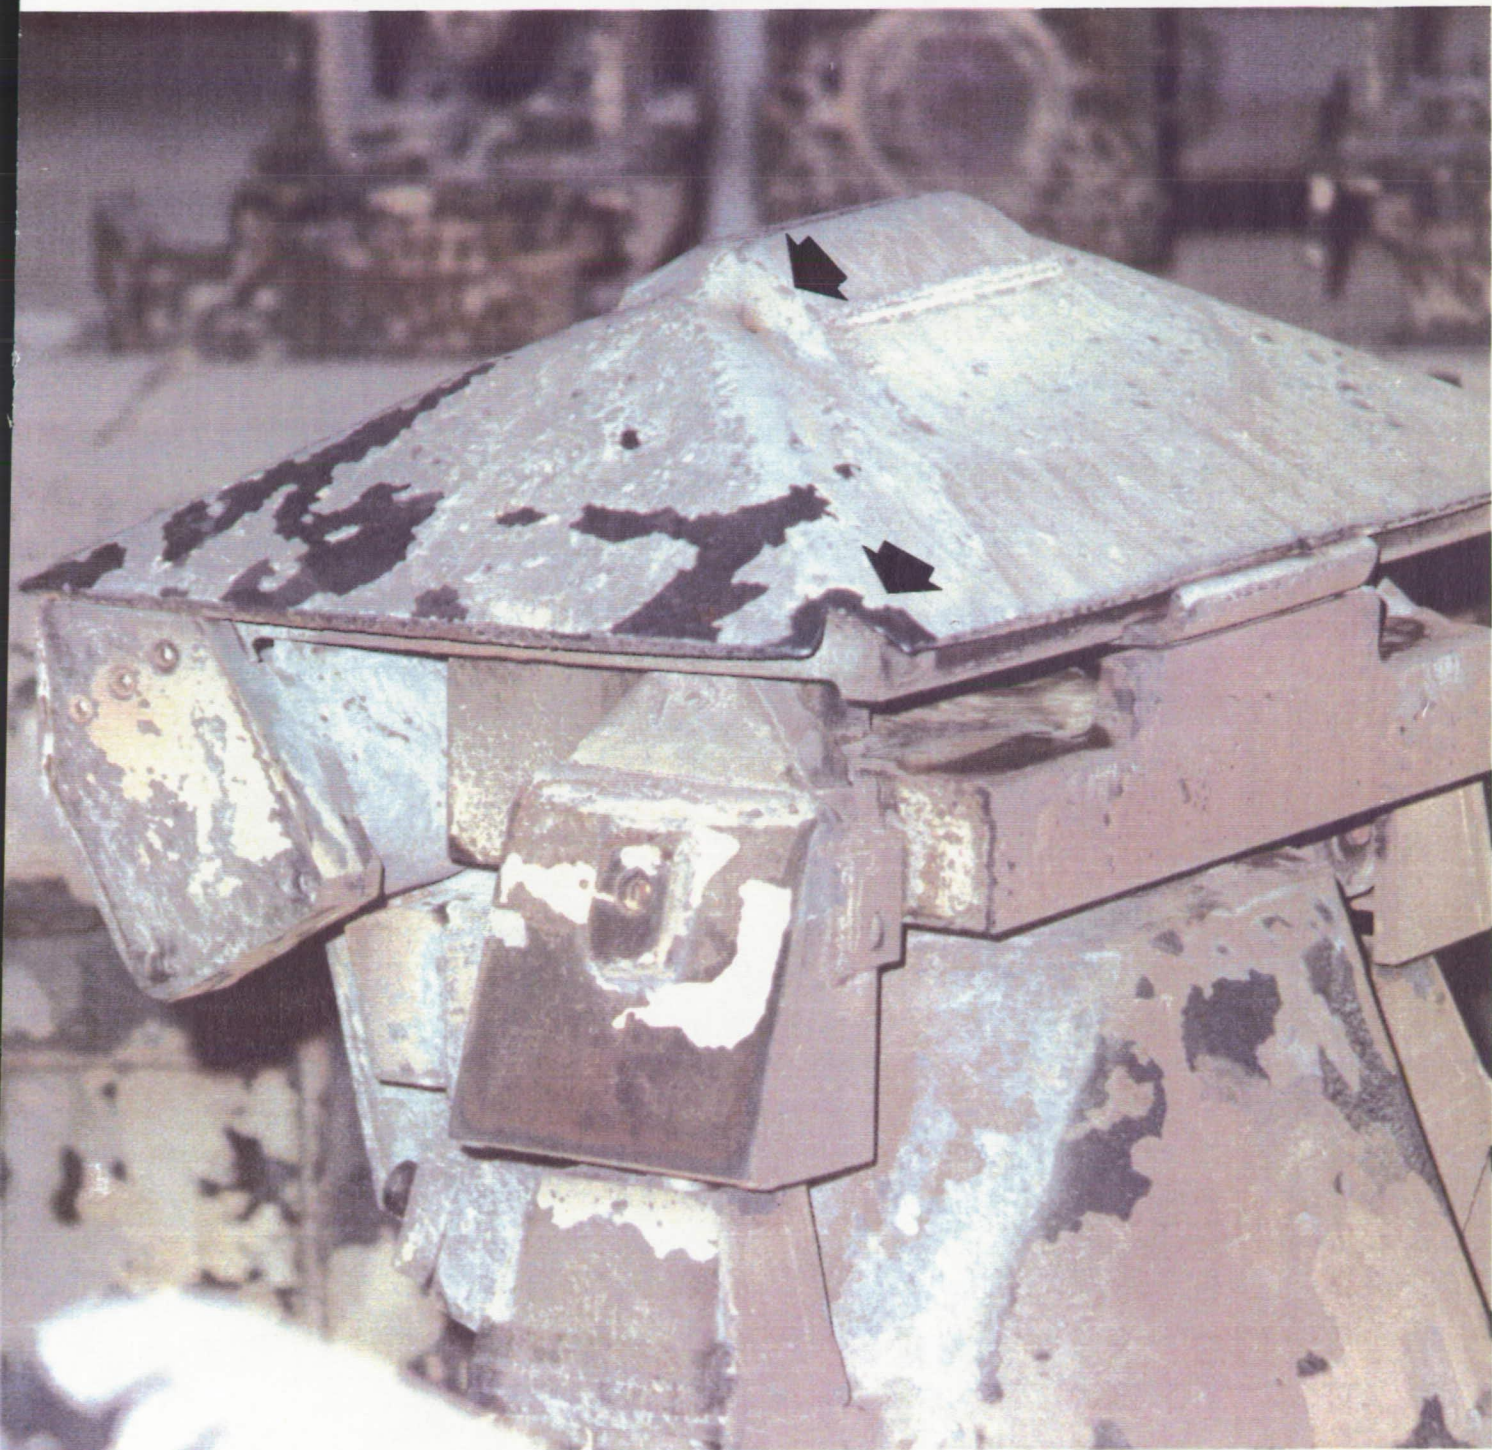
Erosion/heating effects from SRB plume was visible on top and corner of doghouse blast cover

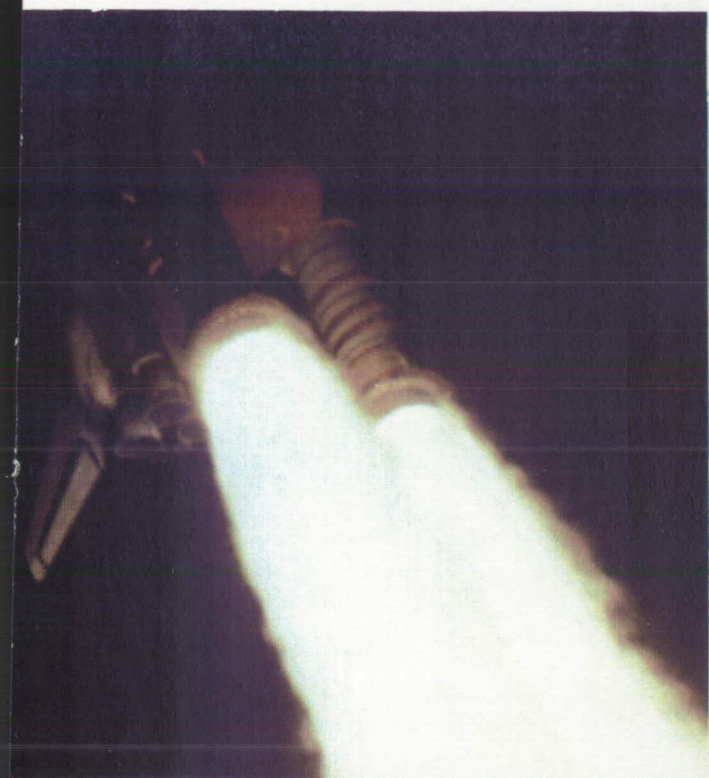
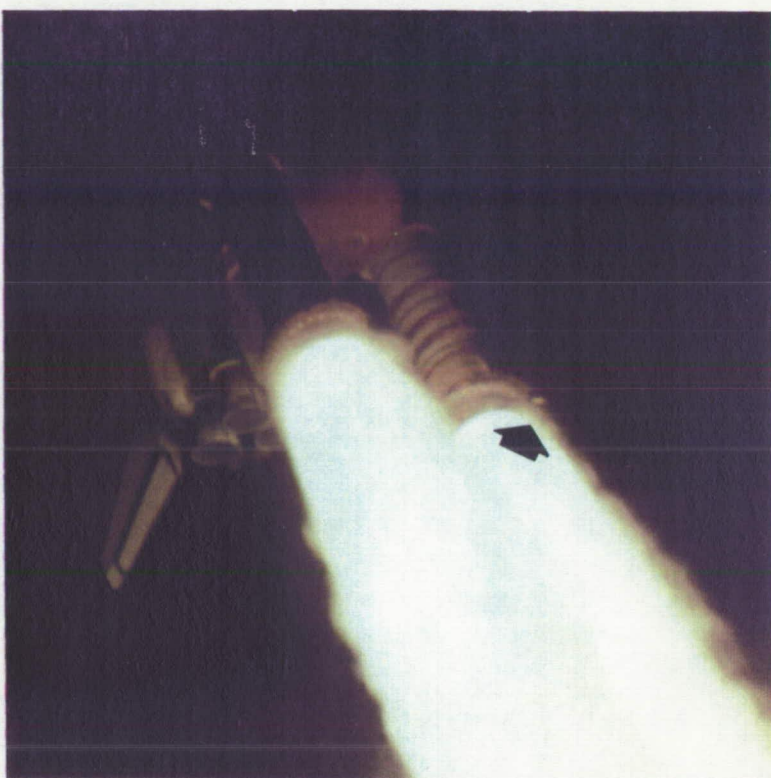
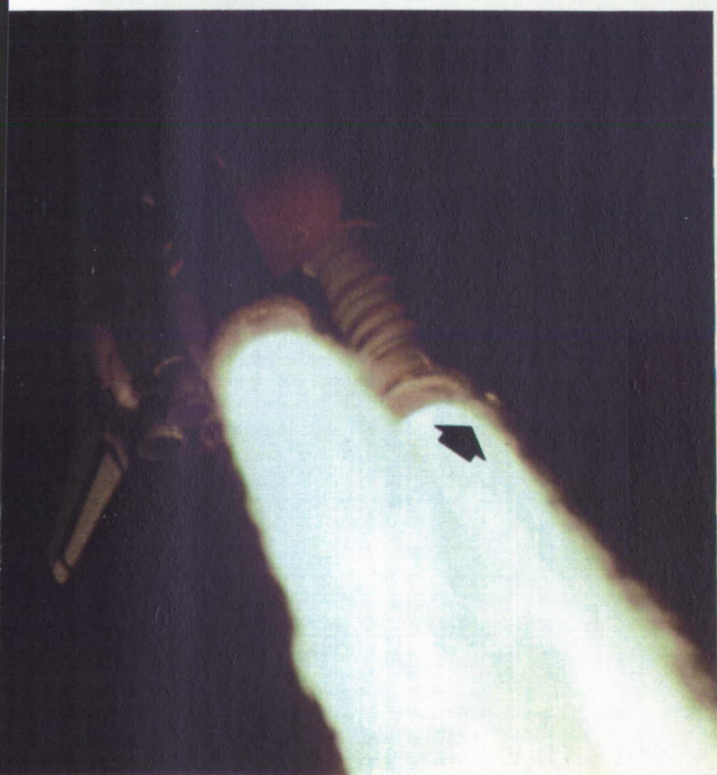
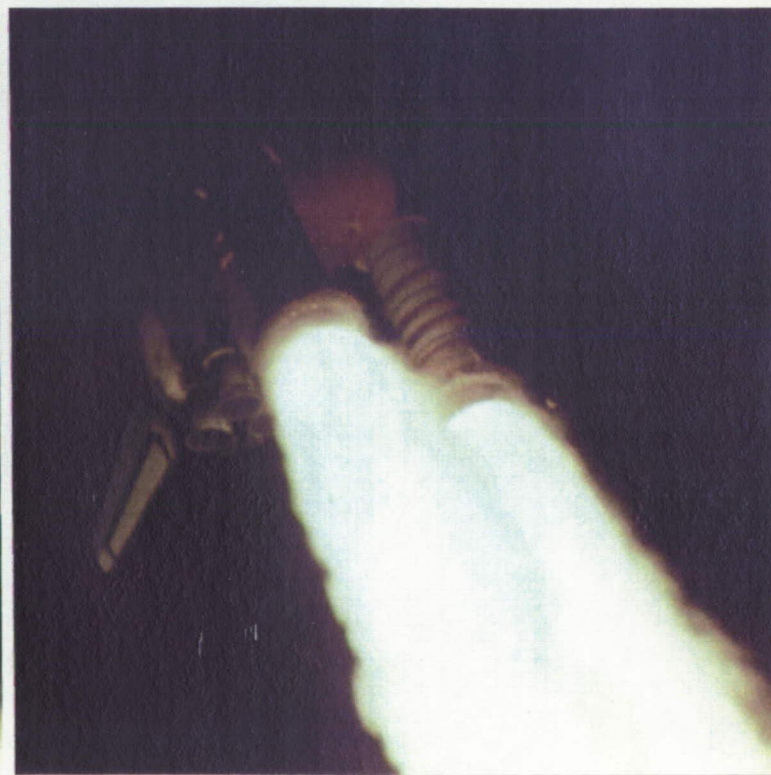
Possible loss of second piece of LH SRB aft skirt thermal curtain material at 39 seconds MET. Both objects' apparent size, mass, and behavior tend to preclude the possibility of SRB thermal curtain tape.

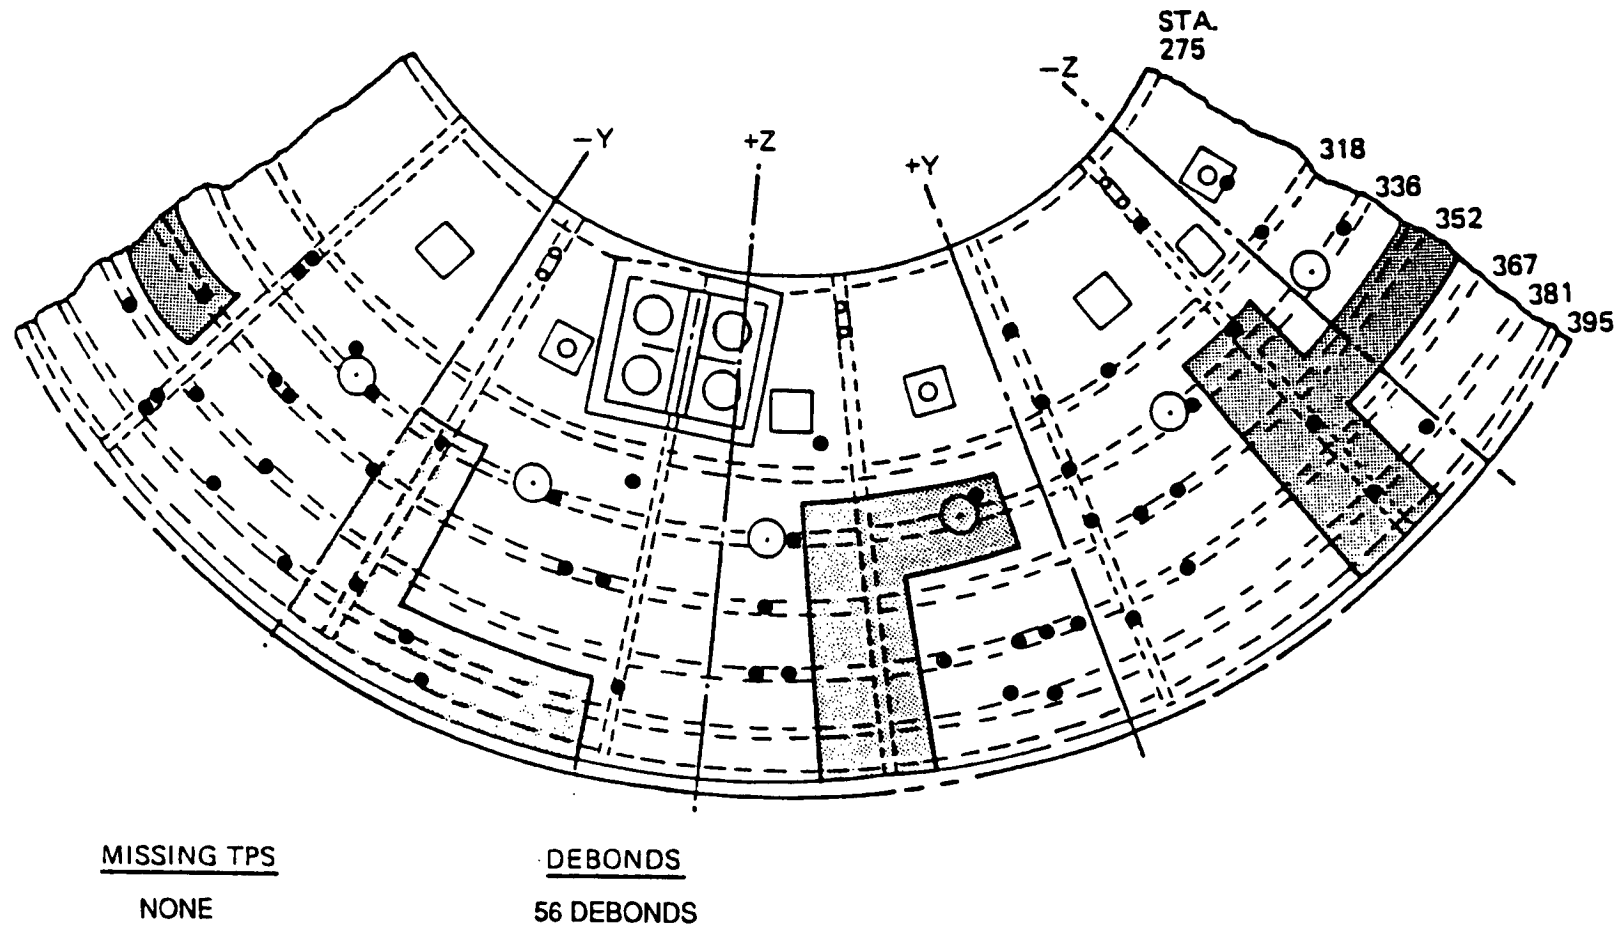
FIGURE 5. RIGHT SRB FRUSTUM

The nose cap was not recovered. The RH frustum had no areas of missing TPS but had 56 debonds over fasteners (Figure 5). The Hypalon paint was blistered slightly in localized areas. All BSM covers were fully opened and locked in the 180 degree position.

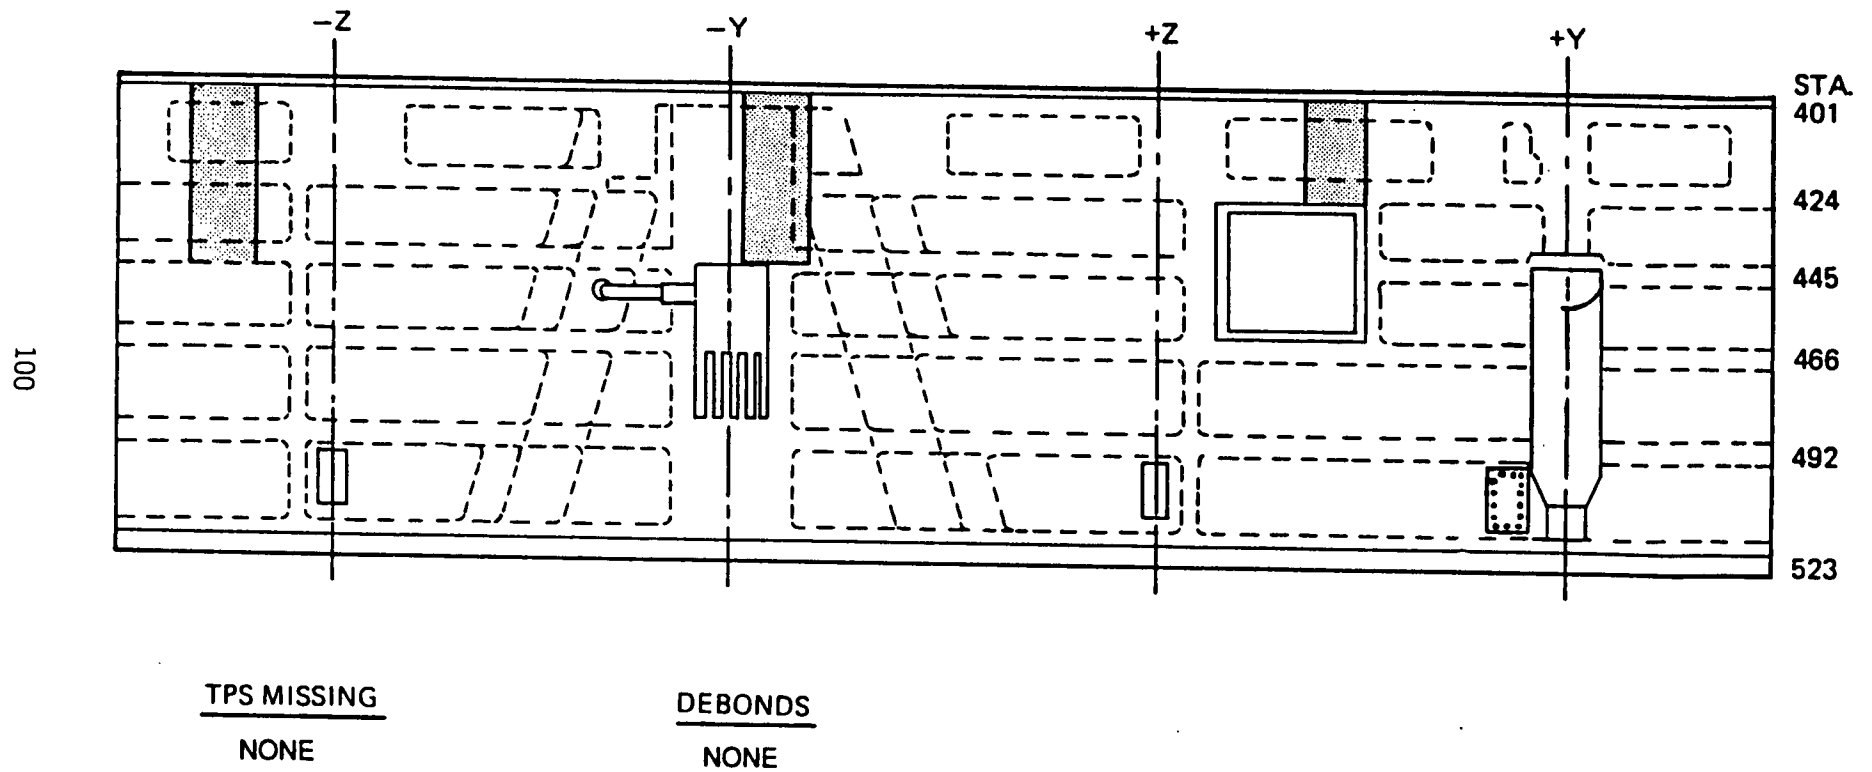
FIGURE 6. RIGHT SRB FWD SKIRT

The RH forward skirt exhibited no debonds or missing TPS (Figure 6). The frustum severance ring, utilizing the new pin retainer clips, was missing no pins. Separation of the forward attach bolt and electrical cables appeared normal.
